# R3 PRO ACCURACY STUDY

# ROCK R3 Pro LiDAR Accuracy Test Overview

Pinn Rd Construction Site - 450' Concrete Barrier Girder Survey Simulation

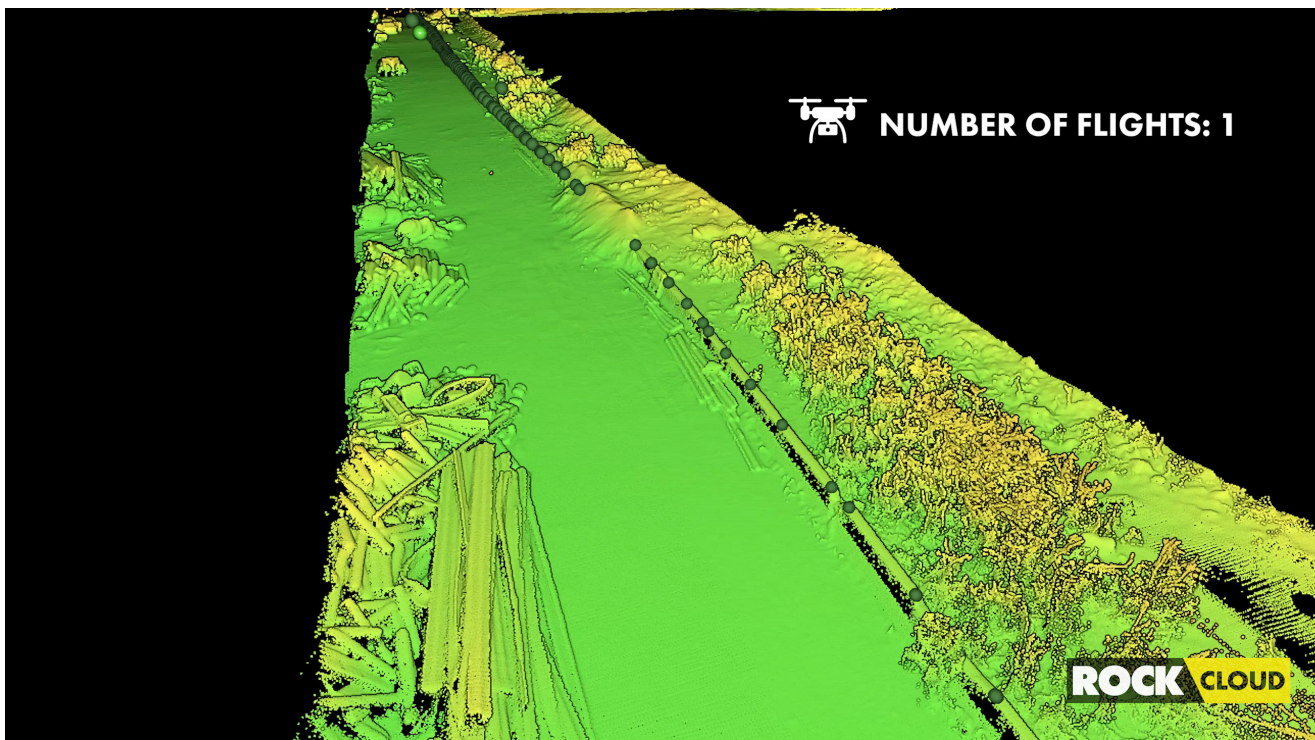
- LSC's survey department established a Local Ground Control Point at the test location.
- Known point and 3 GCPs for the Base Station to be positioned over for the LiDAR survey.
- 141 Total Station Check Shots were captured and withheld to compare the accuracy of the R3 Pro.
- The ROCK LiDAR data was zeroed to the Local Measurements, creating a starting point for accuracy evaluation.

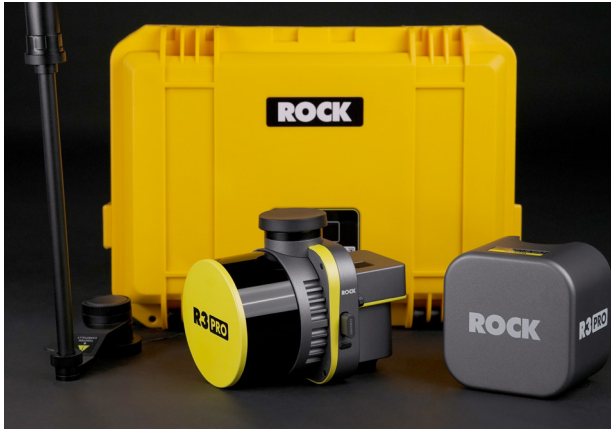
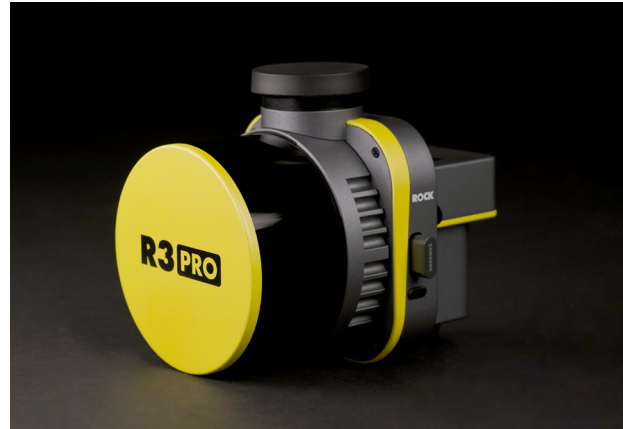
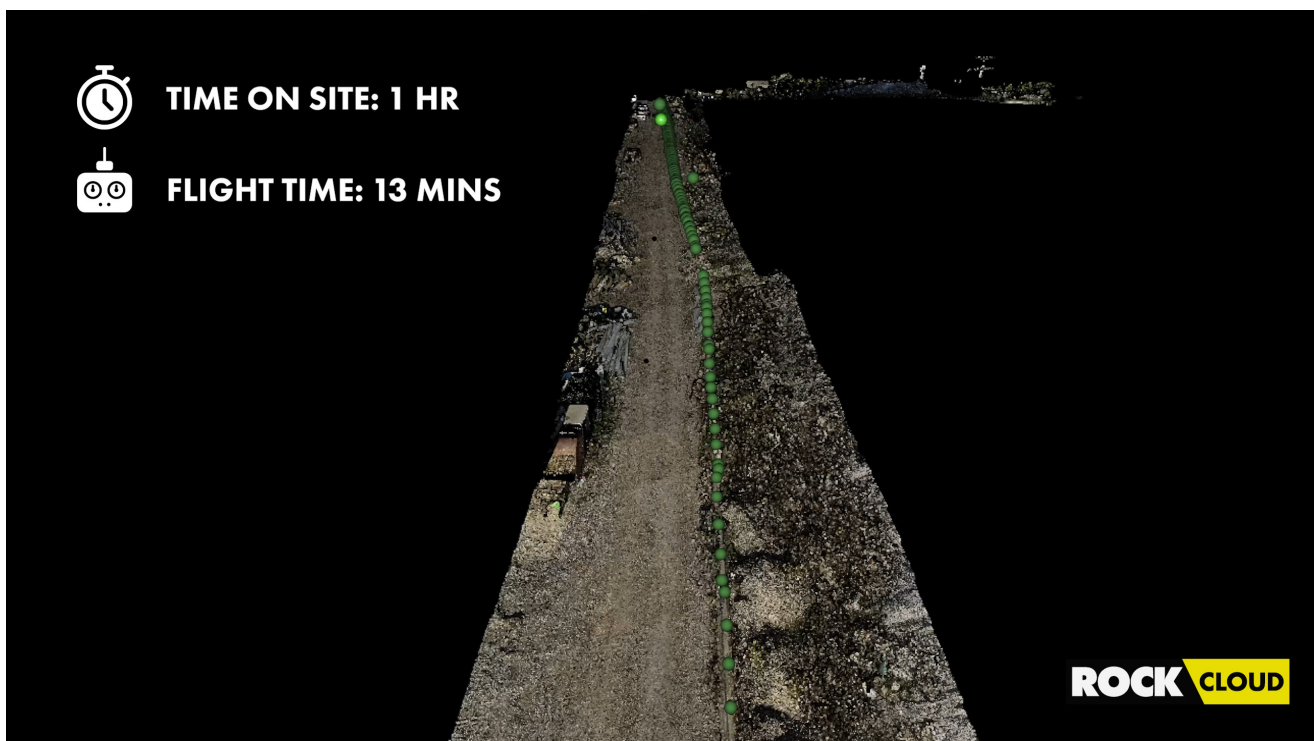
- ROCK demonstrated the setup and execution of the drone LiDAR survey operations in real time.
- Evaluation of safety improvements and potential time savings by replacing manual, high-risk operations with aerial surveys.

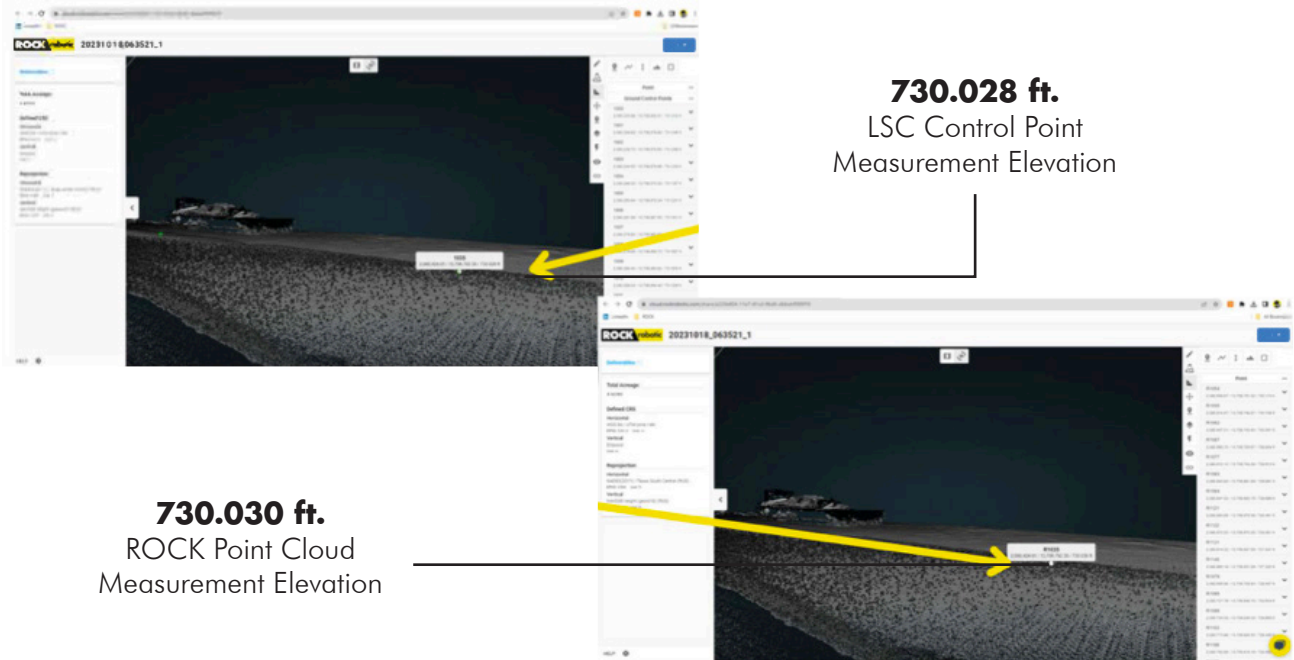
- Raw data from aerial inspection, merged with highly accurate ROCK Base Station data, was processed using ROCK Cloud.
- The data was transformed into a precise point cloud for accuracy assessment.
- Local measurements were imported into the point cloud for a delta assessment, comparing control points with the point cloud data.

LSC SURVEY CONTROL POINTS			
Surveyed	Surveyed X	Surveyed Y	Surveyed Z
1054	2090509.604	13706751.31	730.091
1055	2090514.476	13706748.95	730.09
1062	2090547.035	13706733.49	730.02
1067	2090563.73	13706725.65	729.783
1077	2090612.123	13706704.34	729.487
1083	2090640.937	13706691.56	729.662
1084	2090647.261	13706688.75	729.665
1121	2090864.833	13706575.37	728.429
1122	2090870.21	13706572.36	728.359
1131	2090914.32	13706547.59	727.831
1140	2090960.183	13706521.26	727.227
1076	2090606.609	13706706.91	729.465
1095	2090727.78	13706649.76	729.607
1096	2090734.108	13706646.26	729.636
1103	2090773.966	13706625	729.403
1106	2090790.97	13706616.16	728.841
1109	2090800.224	13706610.39	729.038
1110	2090807.19	13706606.67	728.977
1114	2090827.528	13706596.09	728.944
1139	2090954.221	13706524.49	727.321
1090	2090704.295	13706662.46	729.444
1089	2090697.885	13706665.66	729.501

ROCK MEASUREMENT POINTS			
Name	X	Y	Z
R1054	2090510	13706751	730.0936
R1055	2090514	13706749	730.0886
R1062	2090547	13706733	730.0306
R1067	2090564	13706726	729.7836
R1077	2090612	13706704	729.4926
R1083	2090641	13706692	729.6706
R1084	2090647	13706689	729.6756
R1121	2090865	13706575	728.4306
R1122	2090870	13706572	728.3606
R1131	2090914	13706548	727.8206
R1140	2090960	13706521	727.1996
R1076	2090607	13706707	729.4666
R1095	2090728	13706650	729.6136
R1096	2090734	13706646	729.6436
R1103	2090774	13706625	729.4156
R1106	2090791	13706616	728.8316
R1109	2090800	13706610	729.0496
R1110	2090807	13706607	728.9856
R1114	2090828	13706596	728.9506
R1139	2090954	13706525	727.2966
R1090	2090704	13706662	729.4366
R1089	2090698	13706666	729.4986

MEASUREMENT DEVIATION		
Z Deviation in ft.	Z Deviation in cm	
-0.0025735	-0.078440273	0.07844
0.001426495	0.043479582	0.04348
-0.010573476	-0.322279561	0.32228
-0.000573413	-0.017477613	0.017478
-0.005573504	-0.169880393	0.16988
-0.008573496	-0.261320171	0.26132
-0.010573611	-0.32228366	0.322284
-0.001573487	-0.047959881	0.04796
-0.001573554	-0.047961915	0.047962
0.010426527	0.317800555	0.317801
0.027426391	0.835956399	0.835956
-0.001573496	-0.04796015	0.04796
-0.006573511	-0.2003606	0.200361
-0.007573512	-0.230840636	0.230841
-0.012573212	-0.383231509	0.383232
0.00942649	0.287319422	0.287319
-0.011573445	-0.352758602	0.352759
-0.008573554	-0.261321915	0.261322
-0.006573468	-0.200359299	0.200359
0.024426457	0.744518404	0.744518
0.007426879	0.226371282	0.226371
0.002426499	0.073959691	0.07396
